Engineering Assessment of Two Cylinders Observed at the Douma Incident**- Executive Summary**

Expanded Rev 1 - 27 February 2019

Introduction

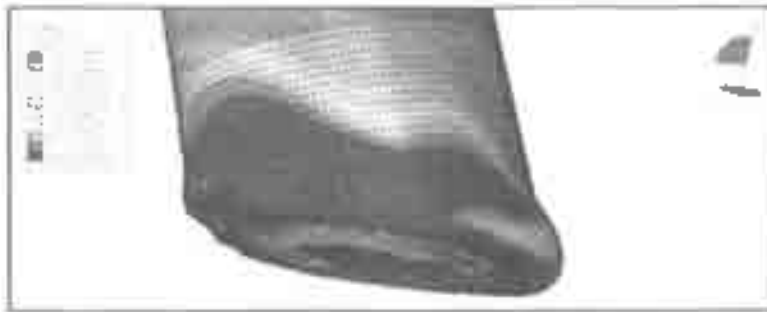
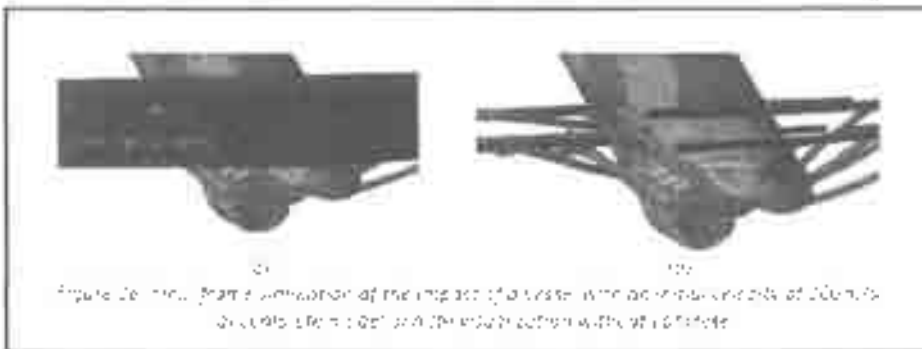
22. As mentioned above, the predicted cylinder deformation was not consistent with that observed on the cylinder observed at the scene at Location 2. The results predicted from the simulation were more consistent with images of deformed cylinders from earlier incidents of cylinders allegedly delivered from helicopters in the Syrian Arab Republic.

Figures 1 & 2 (above): Predicted deformation; initial and final computational analysis.

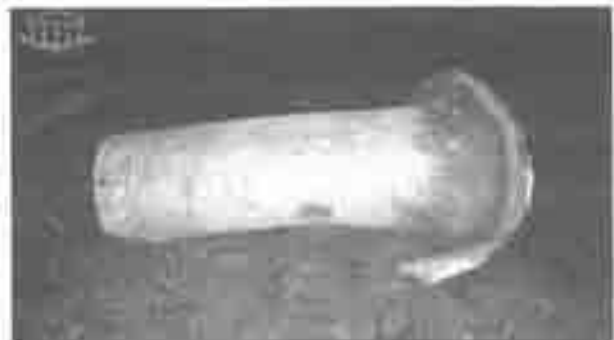
Figures 4 and 5: Cylinders from previous alleged incidents

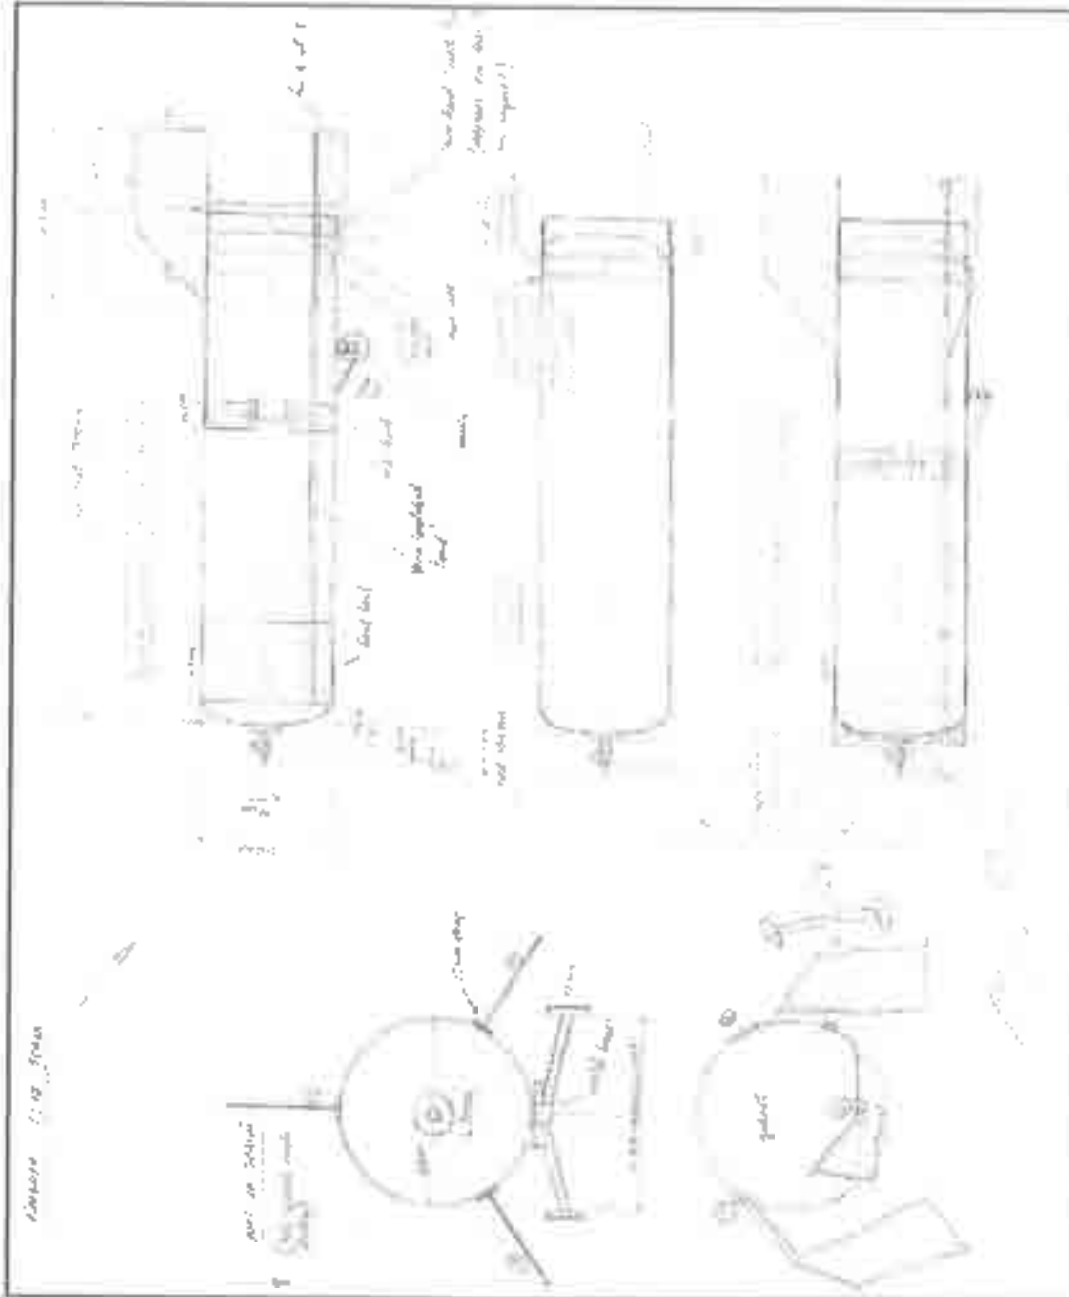
Figure 6: Location 4 cylinder dimensions pre-impact

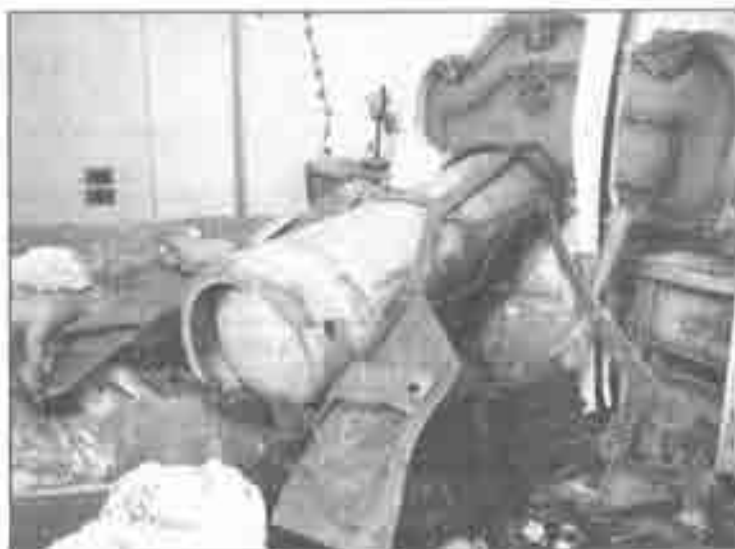
29. Examination of the cylinder, including paintwork, condition of the metal surfaces, and the mild steel attachments, indicated a significant degree of degradation (corrosion) as a result of weathering in the areas that had been damaged through impact. Whilst it may be speculative to consider it unlikely that an old, rusty, already-damaged cylinder would be deployed from an aircraft, the cylinder showed appearance of having spent some post-damage time being exposed to the elements, and would most likely not have degraded to such an extent in the case of it being inside the bedroom.

Figure 8: Cylinder at Location 4

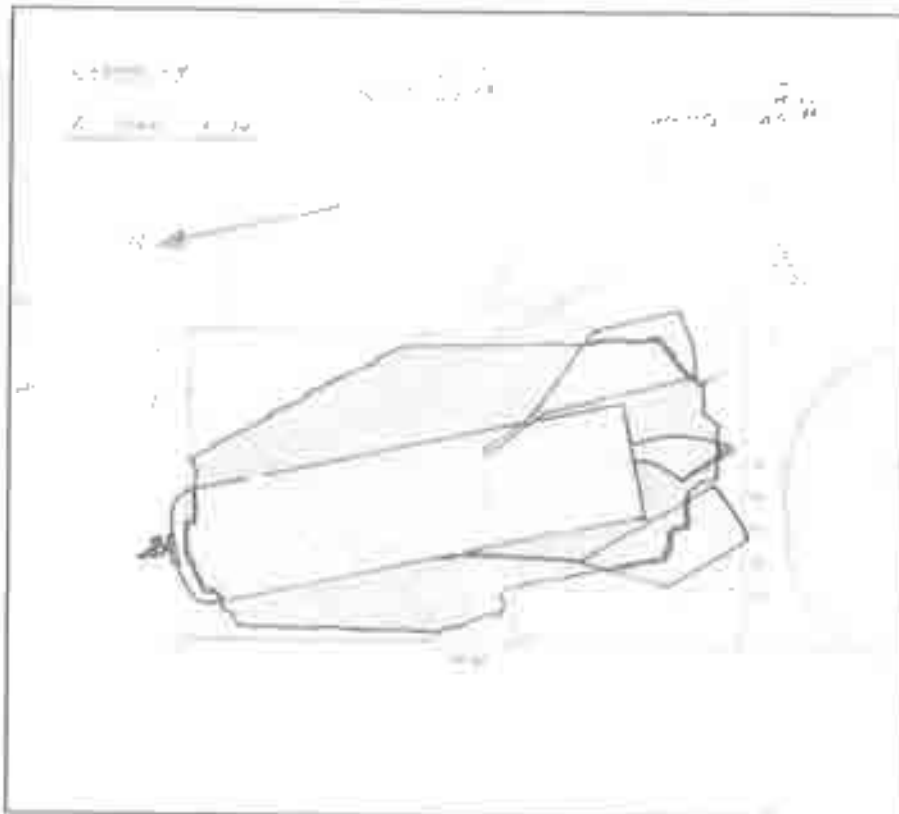
27. In the scaled dimensional analysis on the Location 4 cylinder, pre- and post-deformation, compared with the crater in the roof, it was not possible to establish a set of circumstances where the post-deformation cylinder could fit through the crater with the valve still intact (whether or not an end-cap was assumed to have been fitted at the front end of the cylinder), and the fins deformed in the manner observed. The observed deformation of the cylinder and direction of apparent inertial deformation of attachments, were clearly consistent with a cylinder having impacted in a flat configuration on a horizontal surface, and not that of a cylinder having penetrated through a crater.

Figure 9: Location 4 cylinder post-impact superimposed onto crater (baseline configuration, for illustrative purposes). Sketch from a scaled drawing

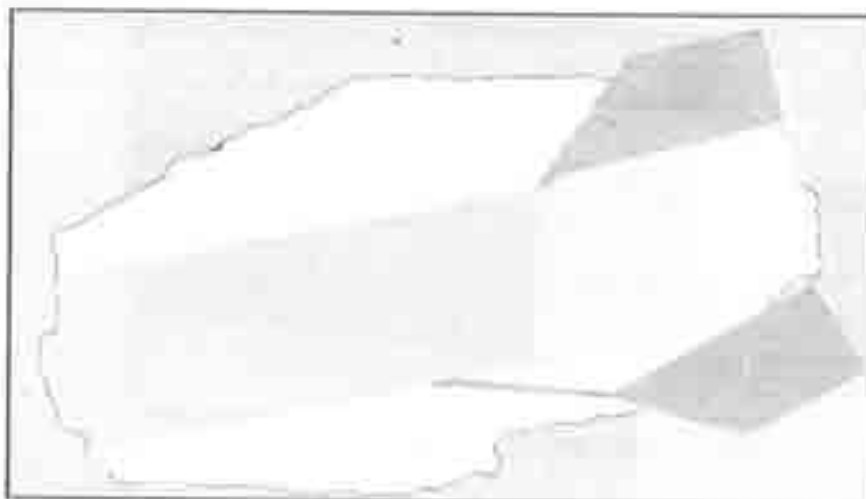
Figure 10: Location 4 cylinder post-impact superimposed onto crater, from dimensional model

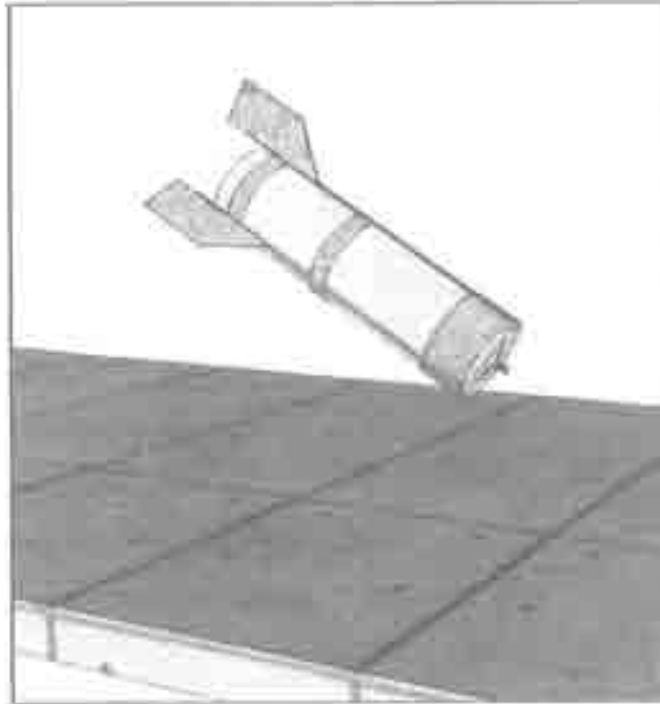
Figure 11: Test case - nose-down angle of incidence

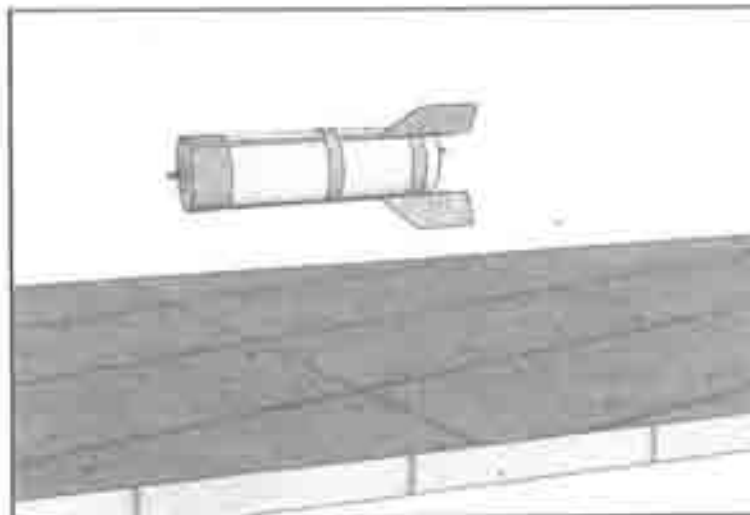
Figure 12: Test case - horizontal angle of incidence

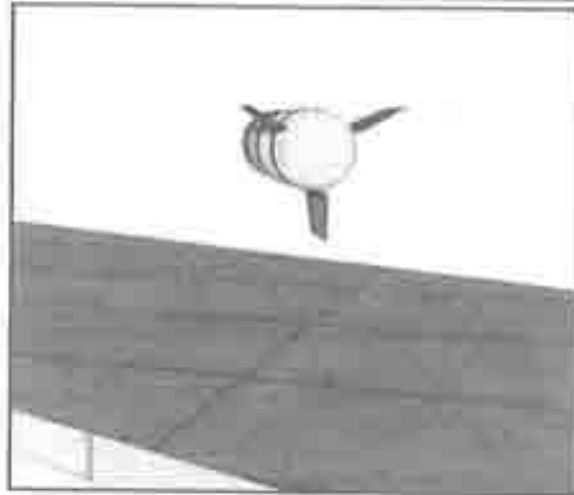
Figure 13: Test case - fin configuration at impact

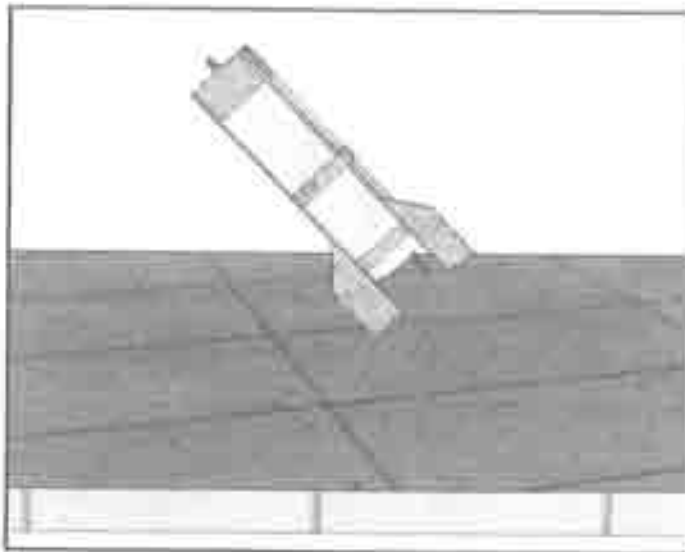
Figure 14: Test case - tail down angle of incidence
